Appendix O

2007 San Luis Drain Shutoff Study

March 2008

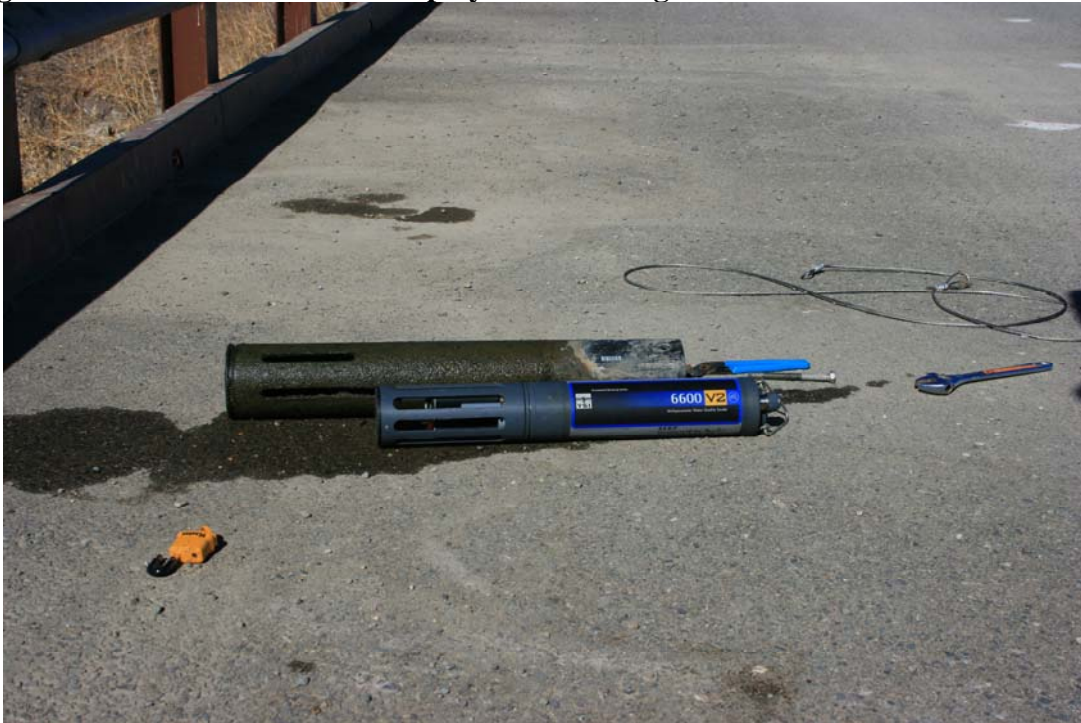
Figure 3: YSI Sonde 6600 with deployment housing.

At field sites, instruments were deployed in custom made PVC housings (Figure 3) for protection against vandalism, theft, and other damage. In general, the instruments in their housings were secured with cable to existing structures in the river. The location of our instrument for site DO-05 SJR at Vernalis was the DWR monitoring platform on the SJR near Vernalis, suspended by cable in its own housing (Figure 4). Sites DO-06 SJR at Maze (Figure 5) and DO-07 SJR at Patterson (Figure 6) were on the SJR at the pumping platforms for the El Solyo and Patterson Irrigation districts respectively. Site DO-08 SJR at Crows was on the SJR at the fishing dock of the Turlock Sportsman's club, also the site for other agencies' (DWR) monitoring (Figure 7). The furthest upstream site on the SJR was DO-10 SJR at Lander Ave, located under the Lander Ave. Bridge (Figure 8). This site required wading into the river and driving a fence post into the river bottom to anchor the instrument and housing. Site DO-18 Mud Slough near Gustine was on Mud Slough, the same location as the USGS flow monitoring station and immediately downstream of the confluence with the San Luis Drain (Figure 9). Here the instrument was hung from the middle of the small bridge over the slough. DO-19 Salt Slough at Lander Ave. was on Salt Slough at a USGS station (Figure 10). The instrument was attached to a fence post attached to the bottom of the slough.

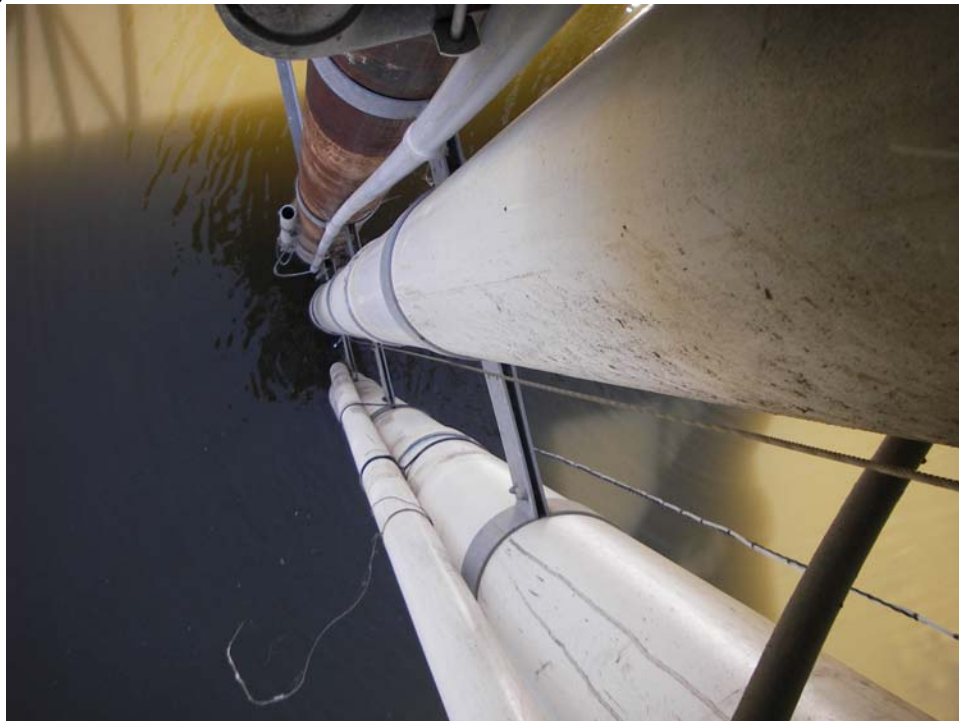
Figure 4: View from DWR Vernalis platform DO-05 looking down at river and stilling wells.

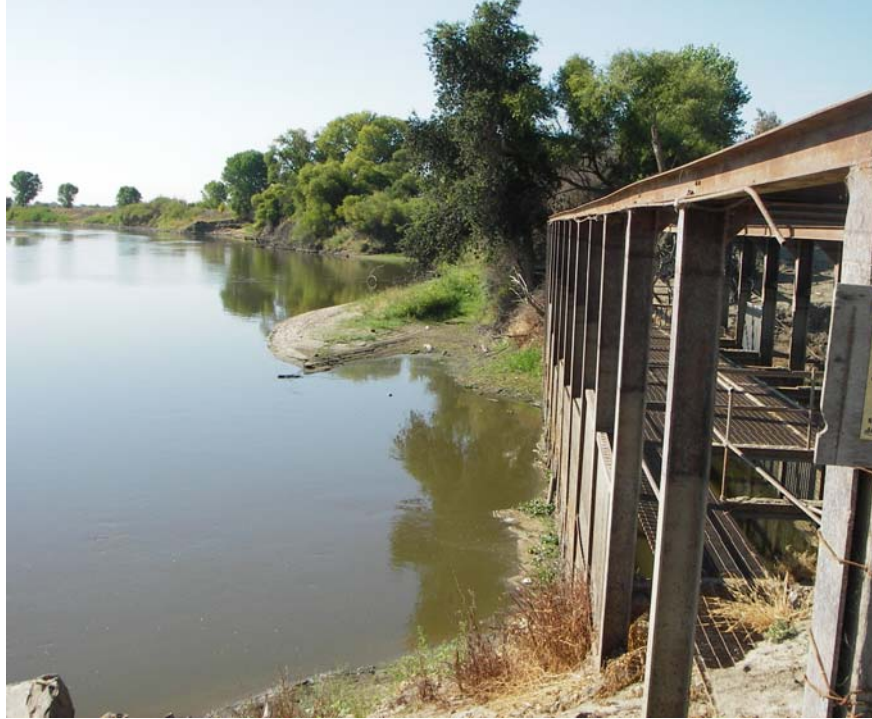
Figure 5: El Solyo Water District intake structure on San Joaquin river, DO-06.

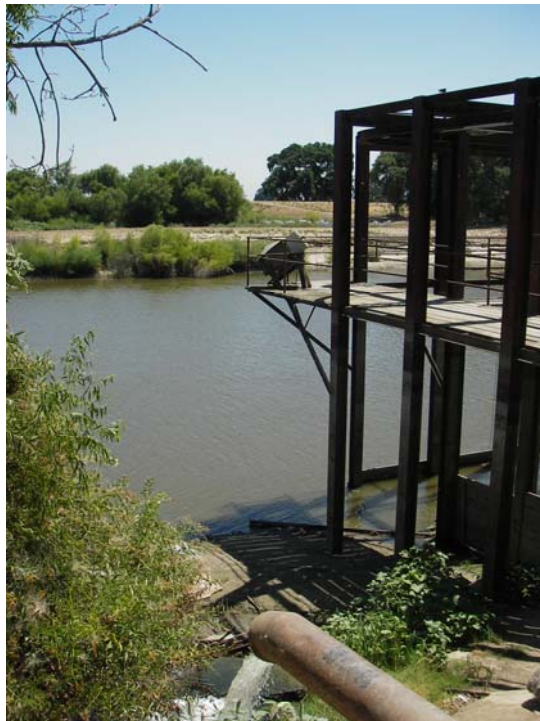
Figure 6: Patterson Irrigation District intake structure on San Joaquin river, DO-07.

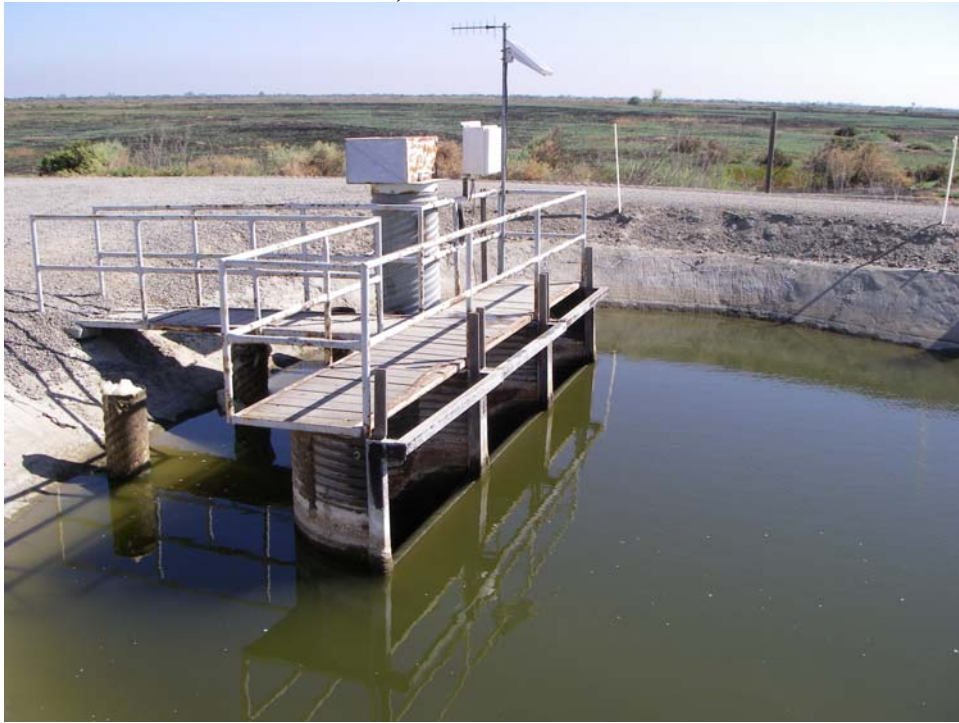
Figure 11: San Luis Drain terminus, DO-44.

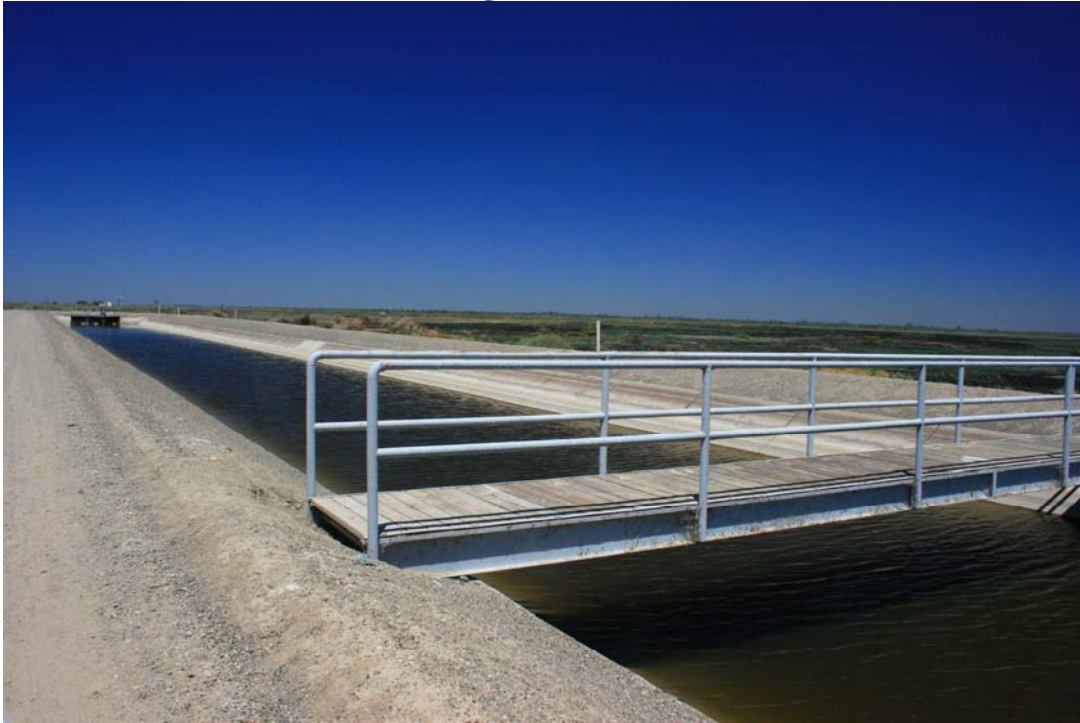
Figure 12: Bridge across SLD about 200 ft upstream of End of Drain outfall (DO-44) Profile was done in middle of bridge.

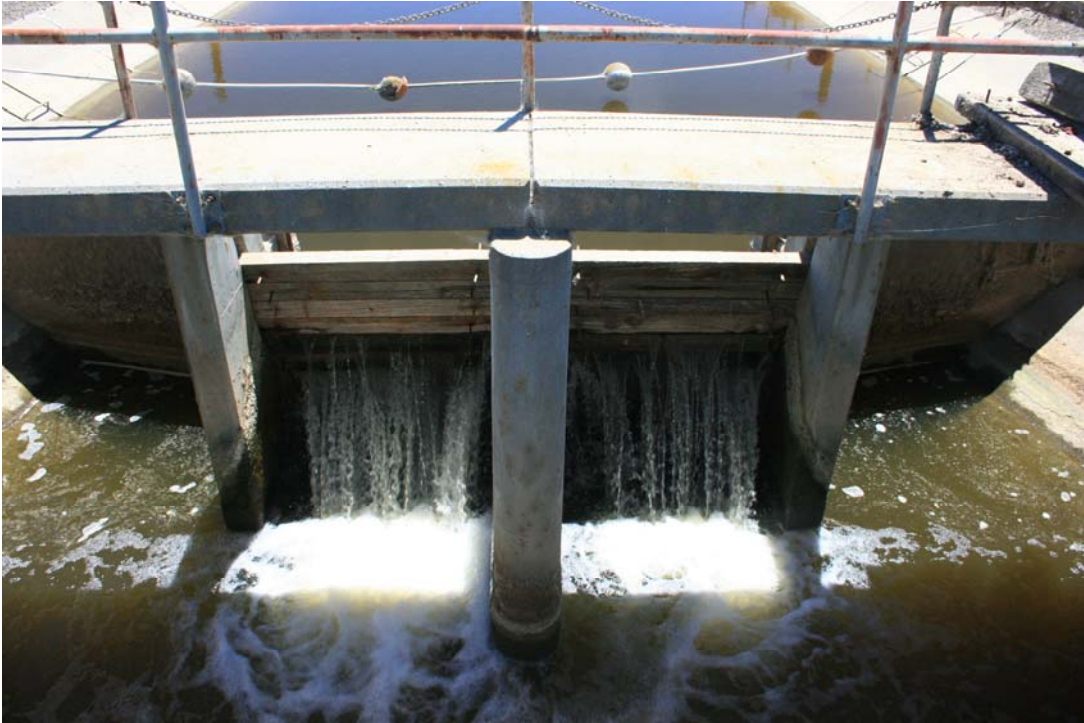
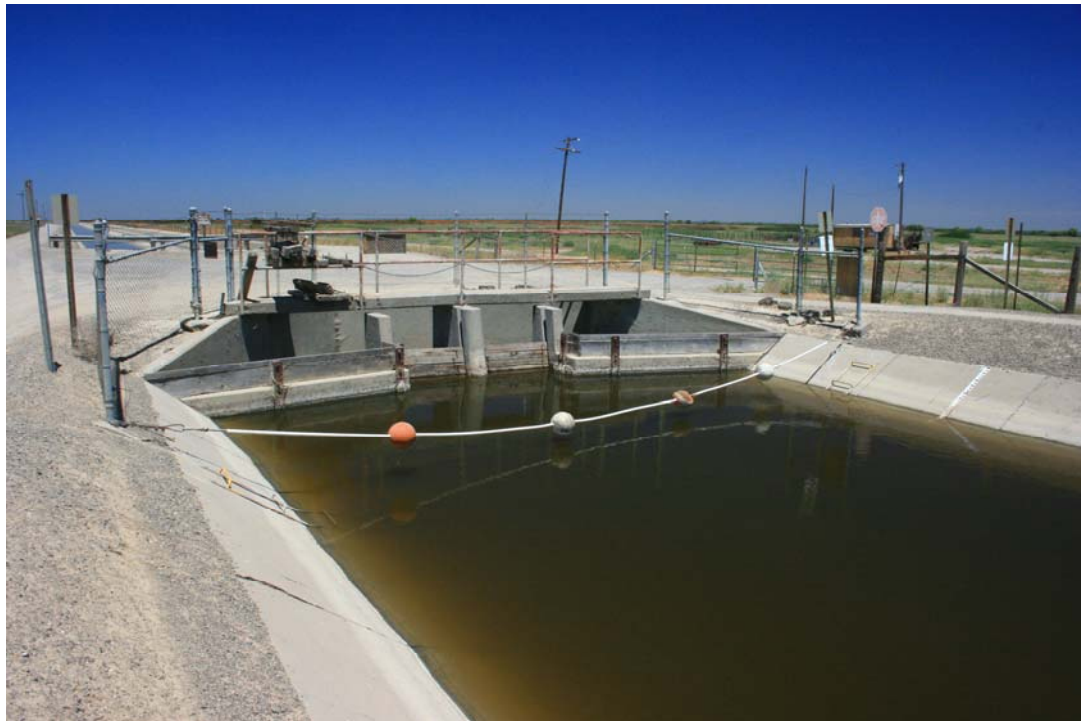
Figure 14: Check Station 1 had leaky boards, sonde profile was performed from wall near boards.

Figure 15: Check Station 1 had leaky boards, sonde profile was performed from wall near boards.

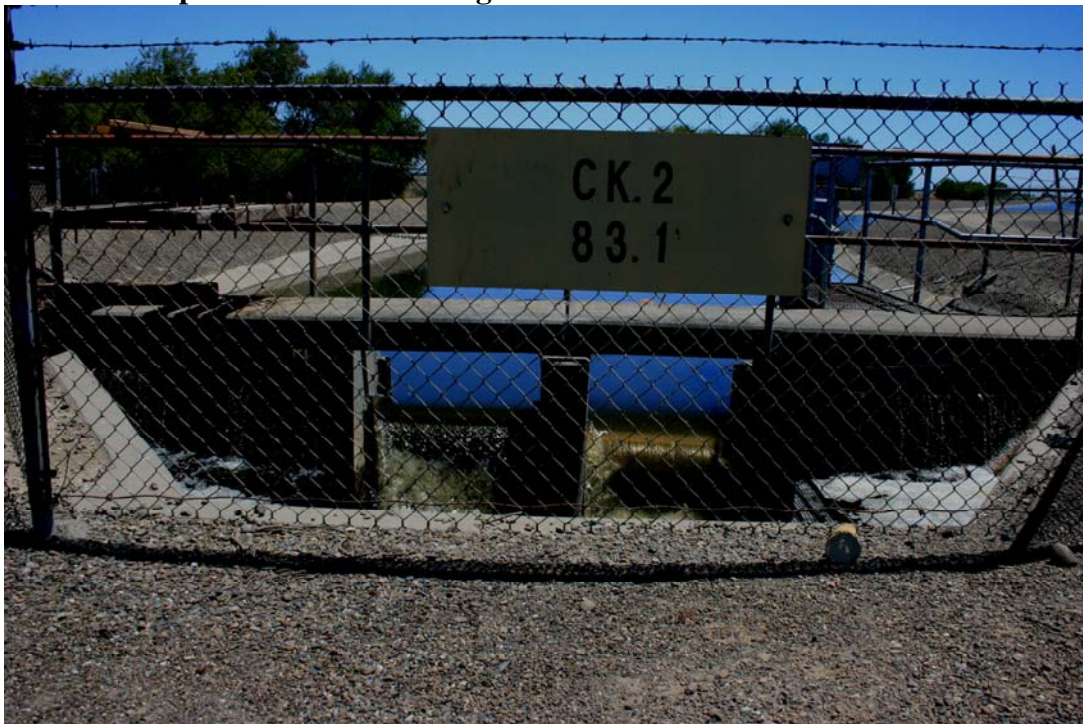
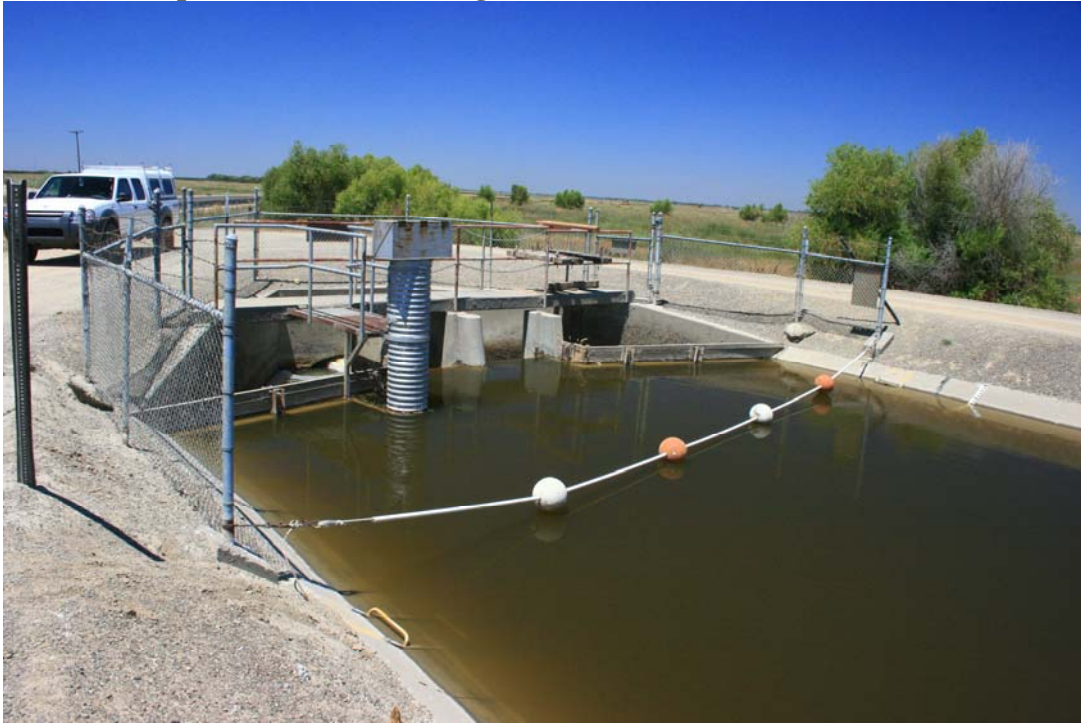
Figure 17: Check Station 2 water had begun to flow over the boards, sonde profile was done from platform where stilling well is located.

Figure 18: Check Station 2 water had begun to flow over the boards, sonde profile was done from platform where stilling well is located.

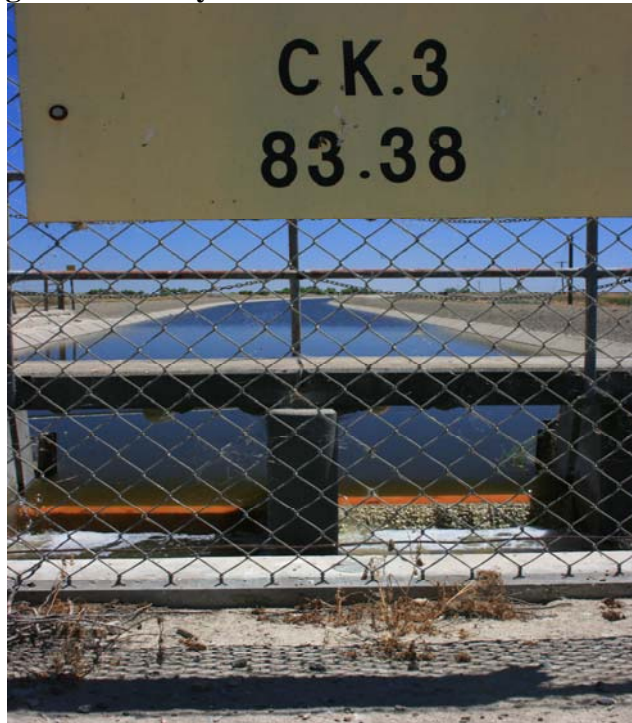
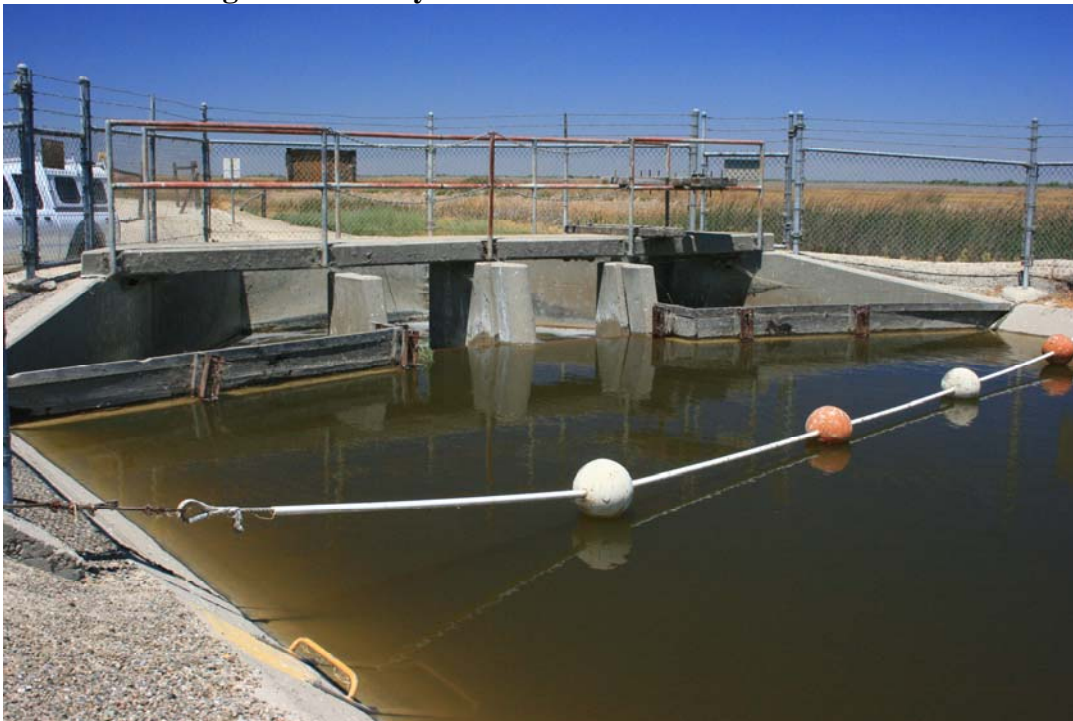
Figure 20: Check Station 3 water was flowing over boards, sonde profile was done from concrete bridge immediately in front of boards.

Figure 21: Check Station 3 water was flowing over boards, sonde profile was done from concrete bridge immediately in front of boards.

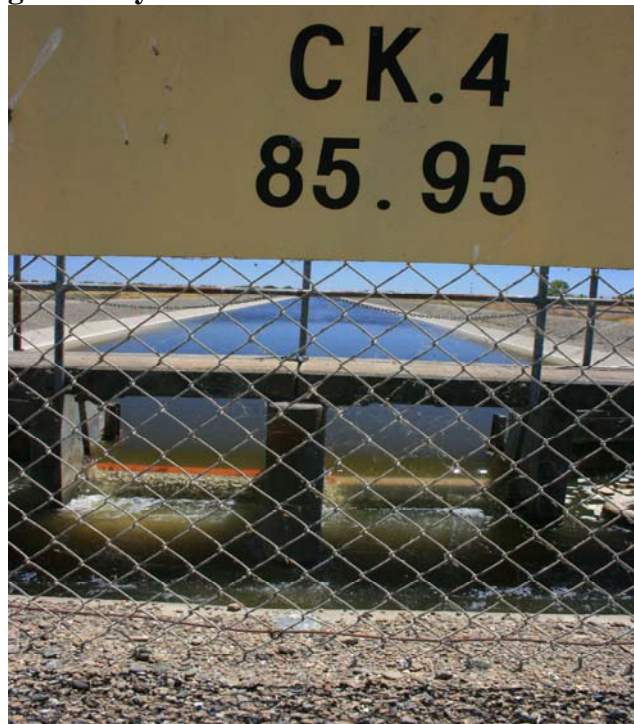
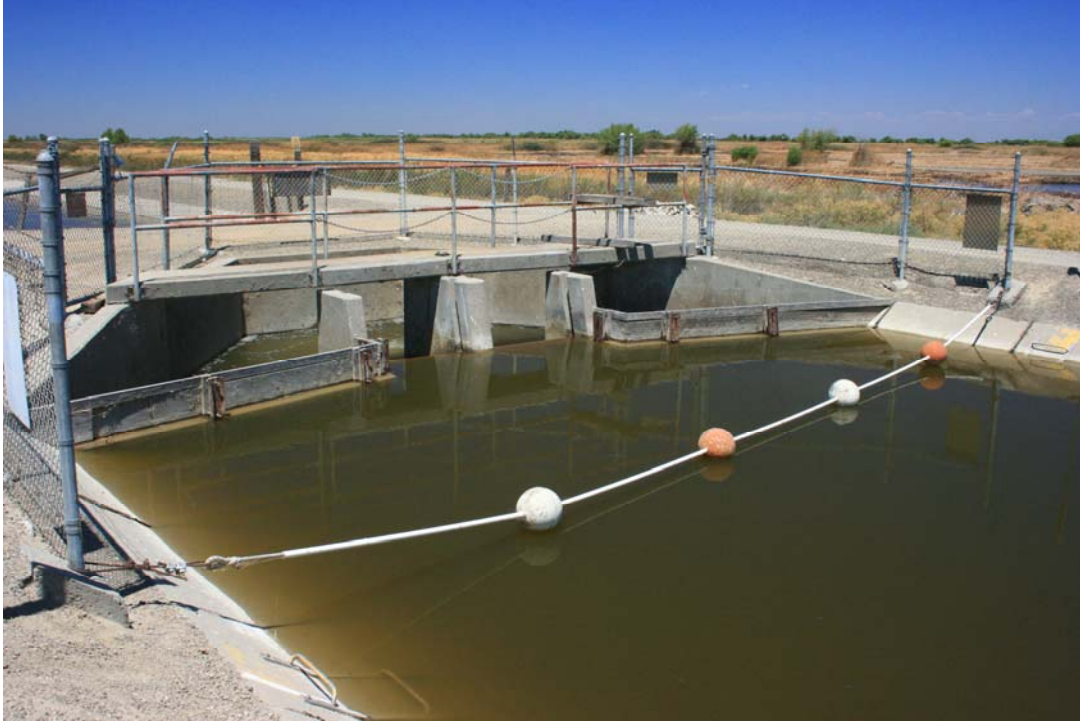
Figure 23: Check Station 4 water flowing over boards, sonde profile was performed from concrete bridge directly in front of weirboards.

Figure 24: Check Station 4 water flowing over boards, strong current made it difficult to keep instrument in place.

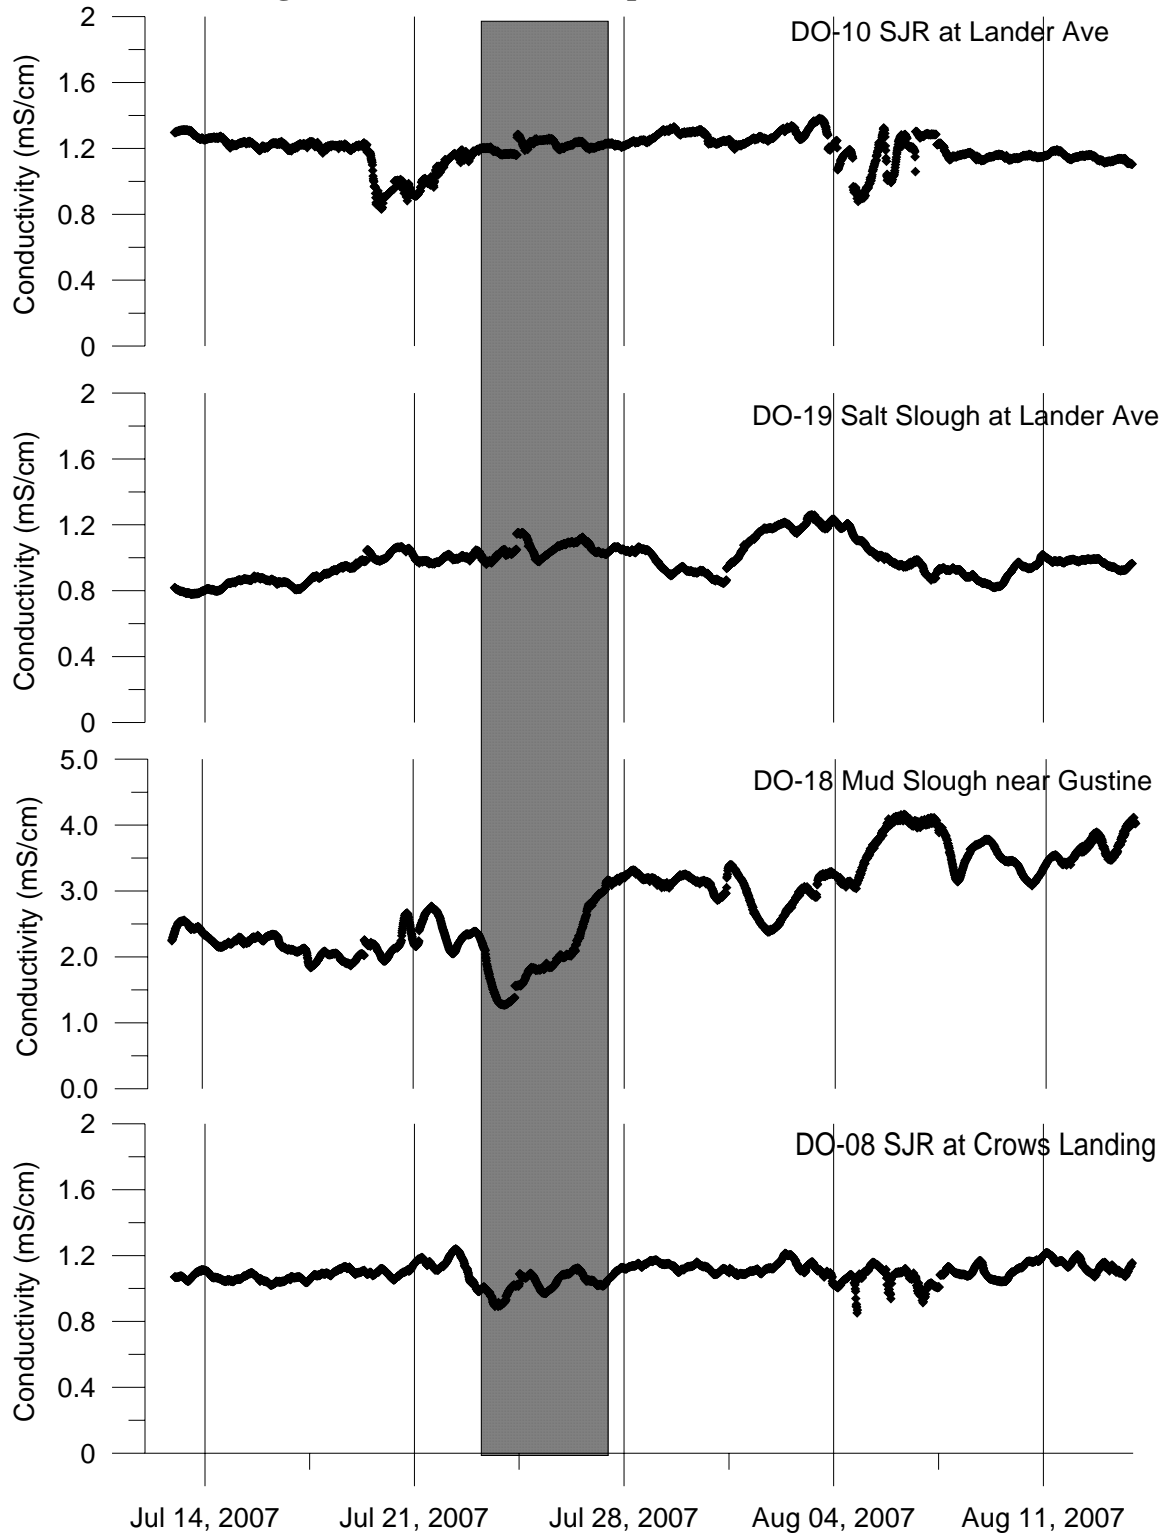
Figure 29: Specific conductance from other tributaries and downstream of San Luis Drain before, during, and after the shutoff experiment.
